Application Notes

MXZ Branch Box Applications with Blue Diamond Pump

MXZ-4C36NAHZ, MXZ-5C42NAHZ, MXZ-8C48NAHZ and MXZ-8C48NA model systems.

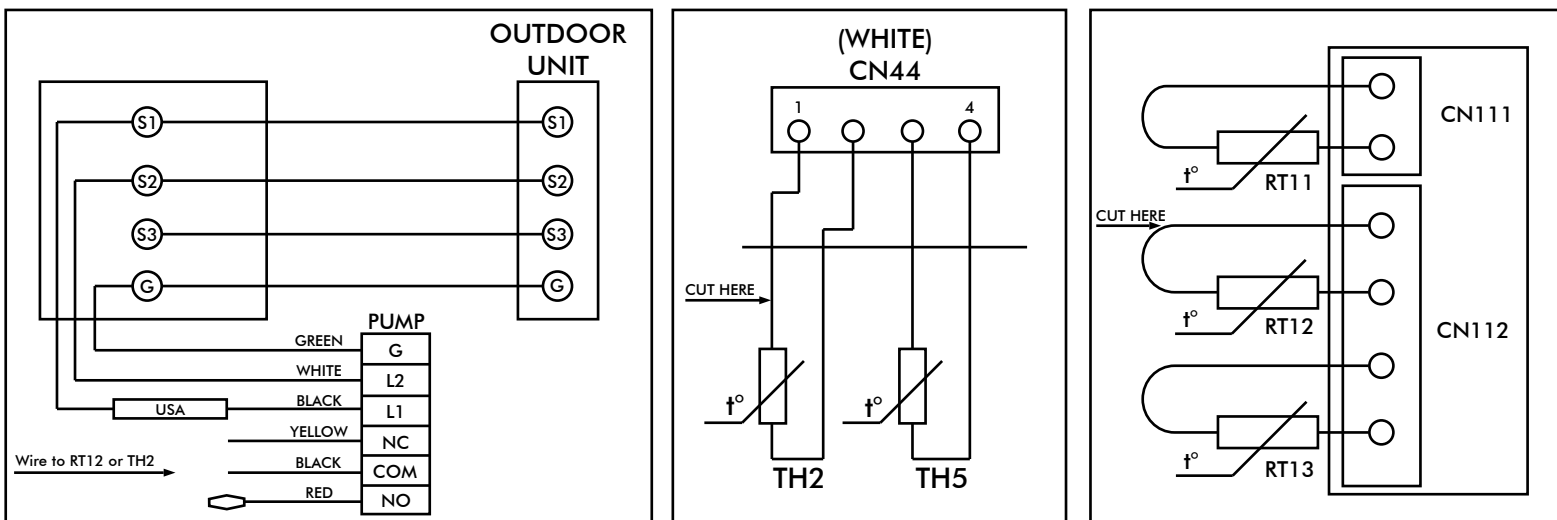
The Blue Diamond pumps have the delay on the NC alarm circuit that will cause a 7102 capacity error when S1 is broken. According to original instructions breaking S1 is the proper way to install the pump and safety switch.

In order to avoid the error condition it will be necessary to break the the coil thermistor of the indoor unit with the electronic level sensor of the Blue Diamond pump. On the indoor unit wiring diagram the coil thermistors will be designated as either RT12 or TH2.

(See Below)

Recommended inlet & outlet tubing is to be 1/4" ID PVC braided tube. All connections should be securely fastened and air tight

Maximum internal diameter of the suction and discharge lines should not exceed 3/8" in areas that are dependant on the pump (i.e. None gravity)
